CEN22FA383

MULTIPLE ELECTRONIC DEVICES

Specialist's Factual Report

Location: Hanna City, IL
Date: August 13, 2022
Time: 12:31 central daylight time (CDT)
17:31 Universal Coordinated Time (UTC)
Airplane: Mooney Aircraft Corp M20K, N30EV

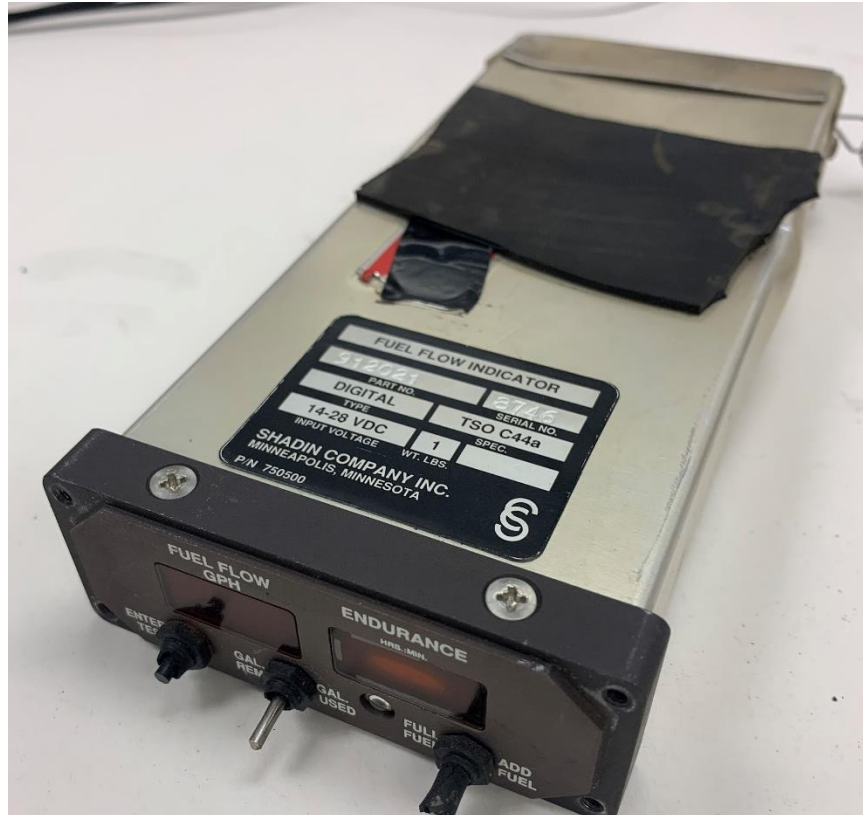
The device is pictured in Figure 1. The device appeared mostly undamaged with the exception of a dent. The device was powered as per the installation manual. The device displayed the following when the appropriate switches were manipulated:

Fuel Flow - 0.0 gph, Gal. Used - 64.9 gal, Gal Rem. (Remain) - 10.1 gal

Figure 1. Photo of Shadin Miniflo.

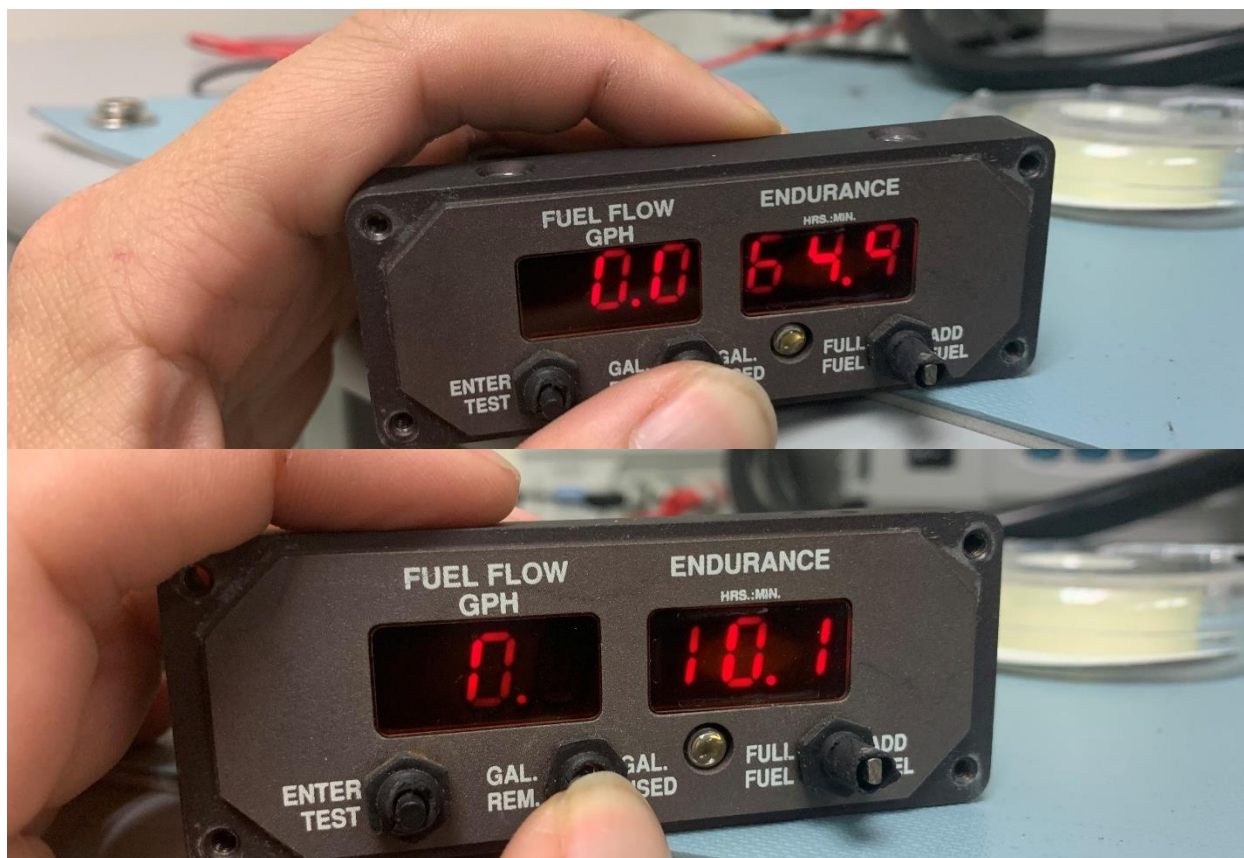
Figure 2 is a photograph of the GAL. USED and GAL. REM. switches manipulated.

Figure 2. Photo of GAL. USED (top) and GAL. REM. (bottom) displayed.

Note that the calculations of fuel status in this device are dependent on the user properly setting the fuel status at the beginning of each power cycle.

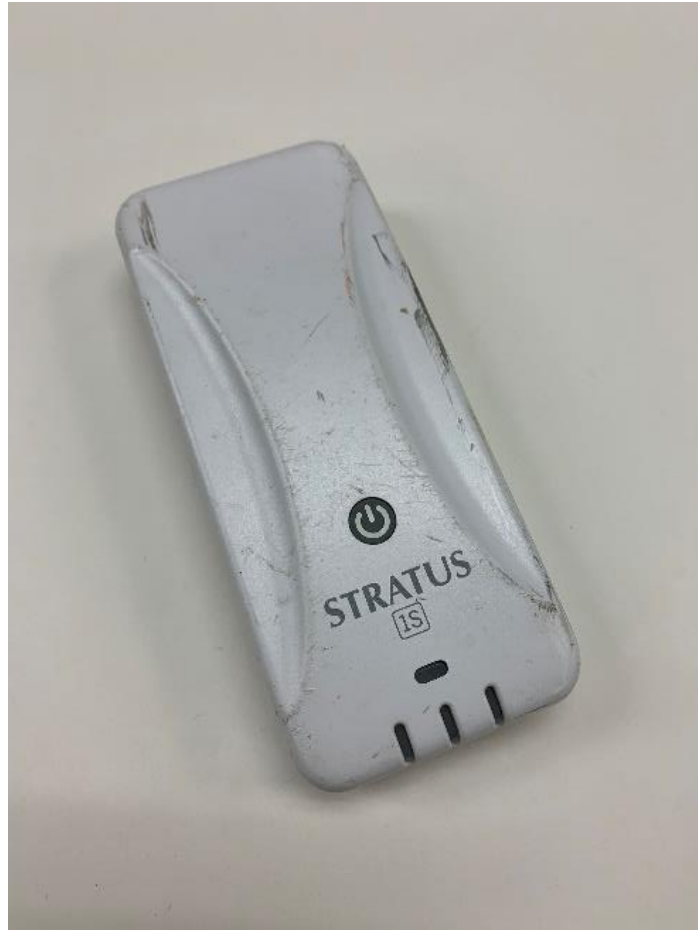
The Appareo Stratus 1s is pictured in Figure 3. The device's outer white case was slightly disjointed, but there was no obvious damage to the functionality of the unit. The device was charged with a USB-C cable and powered. The device powered normally and connected to laboratory iPad running the electronic flight bag (EFB) application Foreflight. Foreflight showed that the device's logging function was turned off (Figure 4). No track logs were discovered on the device. No data relevant to the accident flight was recovered from the device.

Figure 3. Photo of Appareo Stratus 1s.

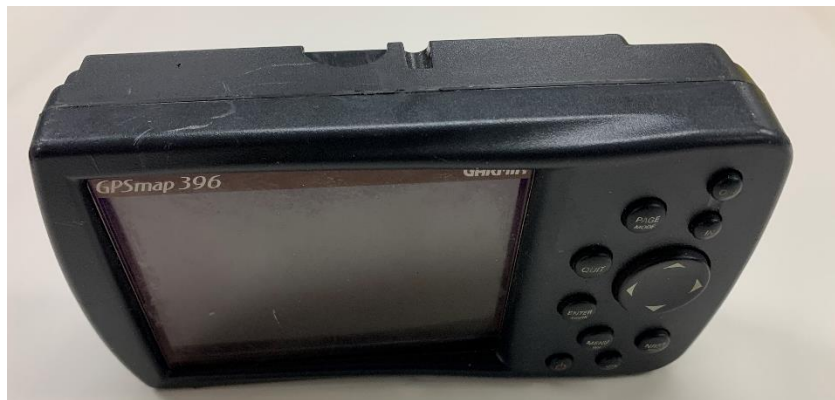
The device arrived at the laboratory exhibiting little obvious damage. The device is pictured in Figure 7. The device was plugged in to a PC via USB and powered normally. Tracklog data was extracted from the device and is discussed below in this report.

Figure 7. Photo of GPS as received.

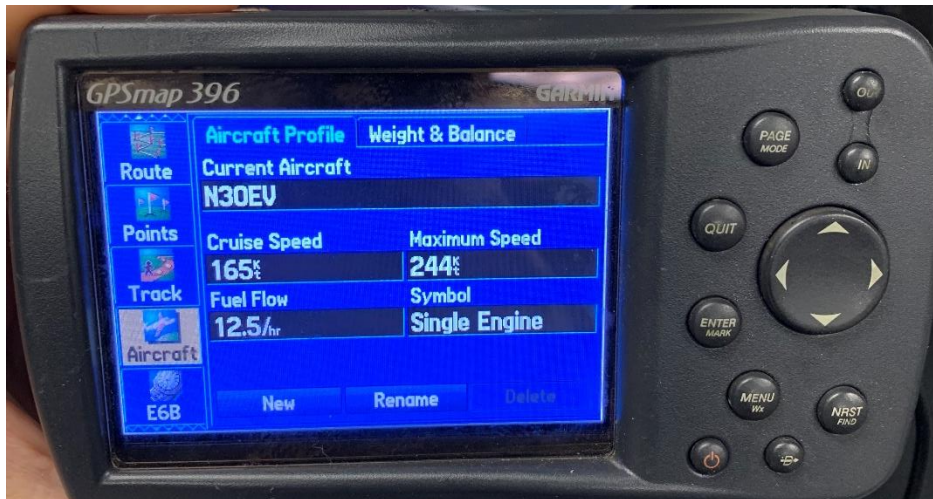
Figure 9 shows the device's "Aircraft Profile" tab in the "Aircraft" page. The profile tab lists the accident aircraft tail number and the fuel flow was entered by the user as 12.5 gallons per hour.

Figure 9. Photo of "Aircraft Profile" tab in the "Aircraft" page.

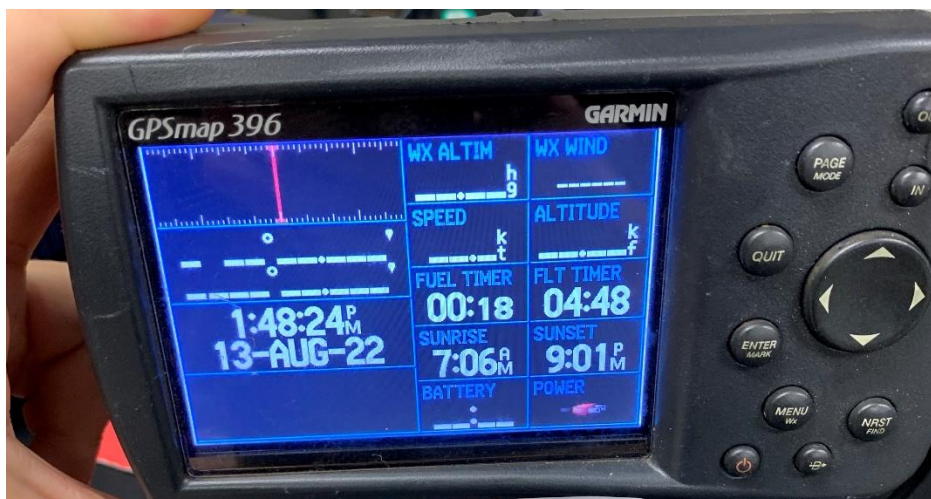
Figure 11 shows an information page that displayed a fuel timer and a flight time. The values are as shown in the figure.

Figure 11. Photo of an information page that showed values for the fuel timer and flight timer. Note that these values may be representative of when the device powered off, which may have occurred after the accident.

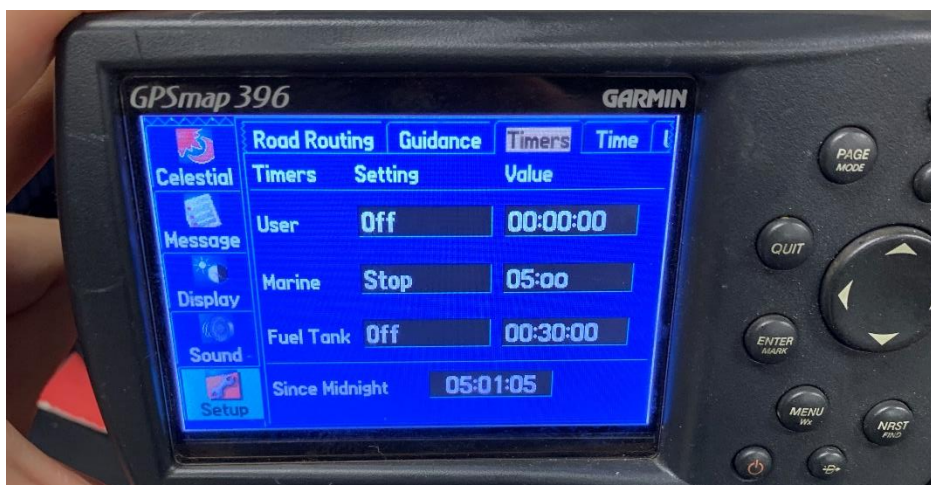
Figure 12 is the setup page for the "Timers" settings. The values are shown in the figure.

Figure 12. Photo of the setup page for the "Timers" settings.

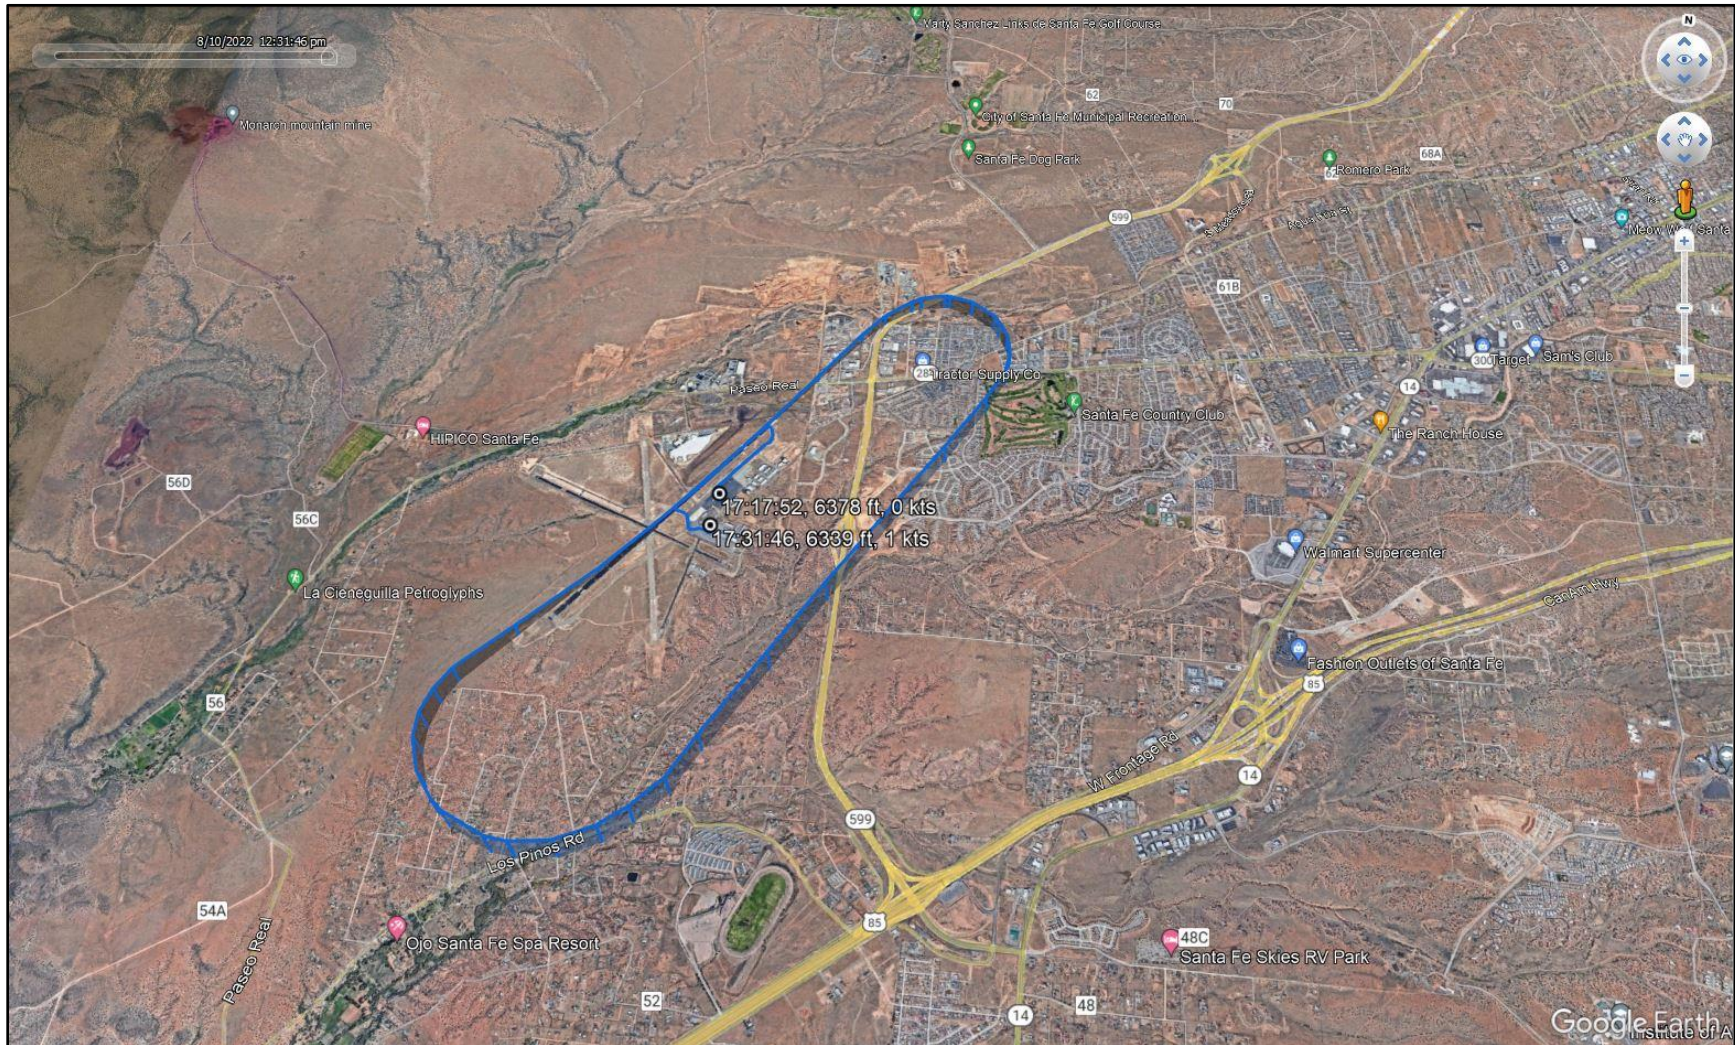
Figure 14 is a graphical overlay generated using Google Earth showing the aircraft's operations at KSAF on August 10, 2022. The tracklog shows the aircraft flying one pattern at KSAF. The total duration of the recording that showed the aircraft was airborne was approximately 4 minutes.

Figure 14. Plot of GPS tracklog data in the vicinity of KSAF on August 10, 2022.

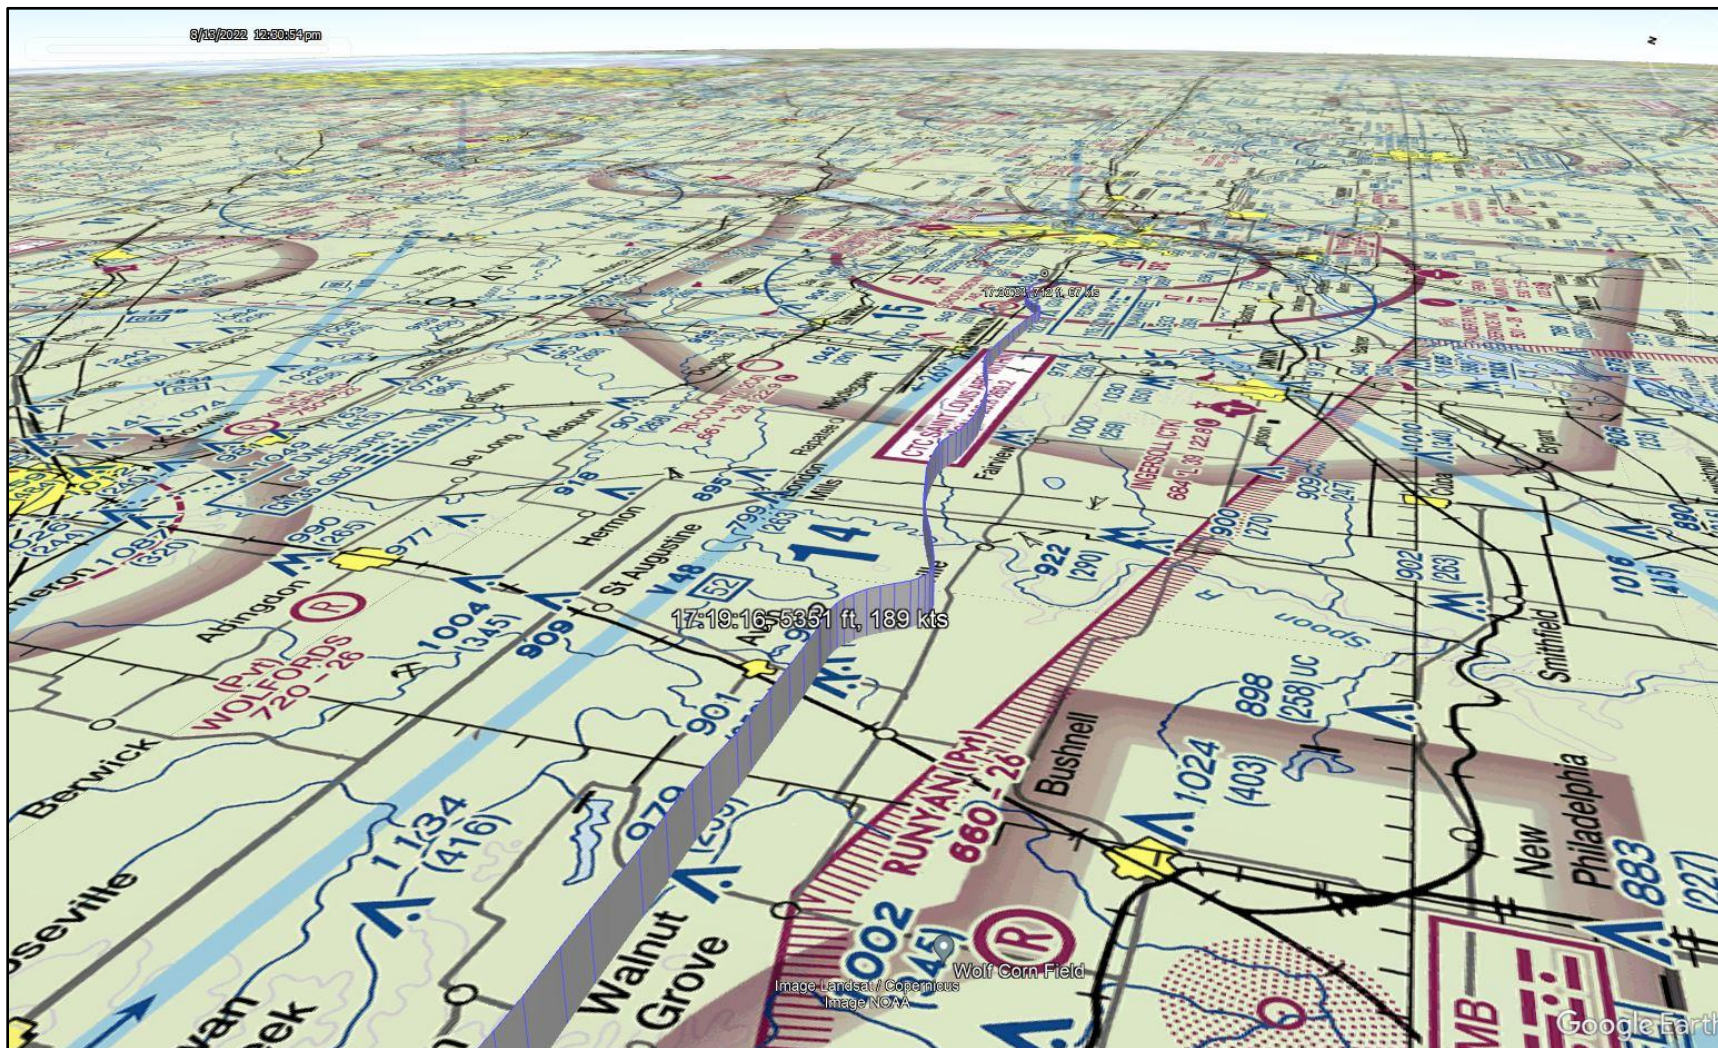
Figure 18 graphical overlay generated using Google Earth showing a view along the tracklog of the aircraft toward the accident site. A sectional chart for this region is overlaid.

Figure 18. An alternative view of the GPS tracklog data during the aircraft's descent to the accident site.

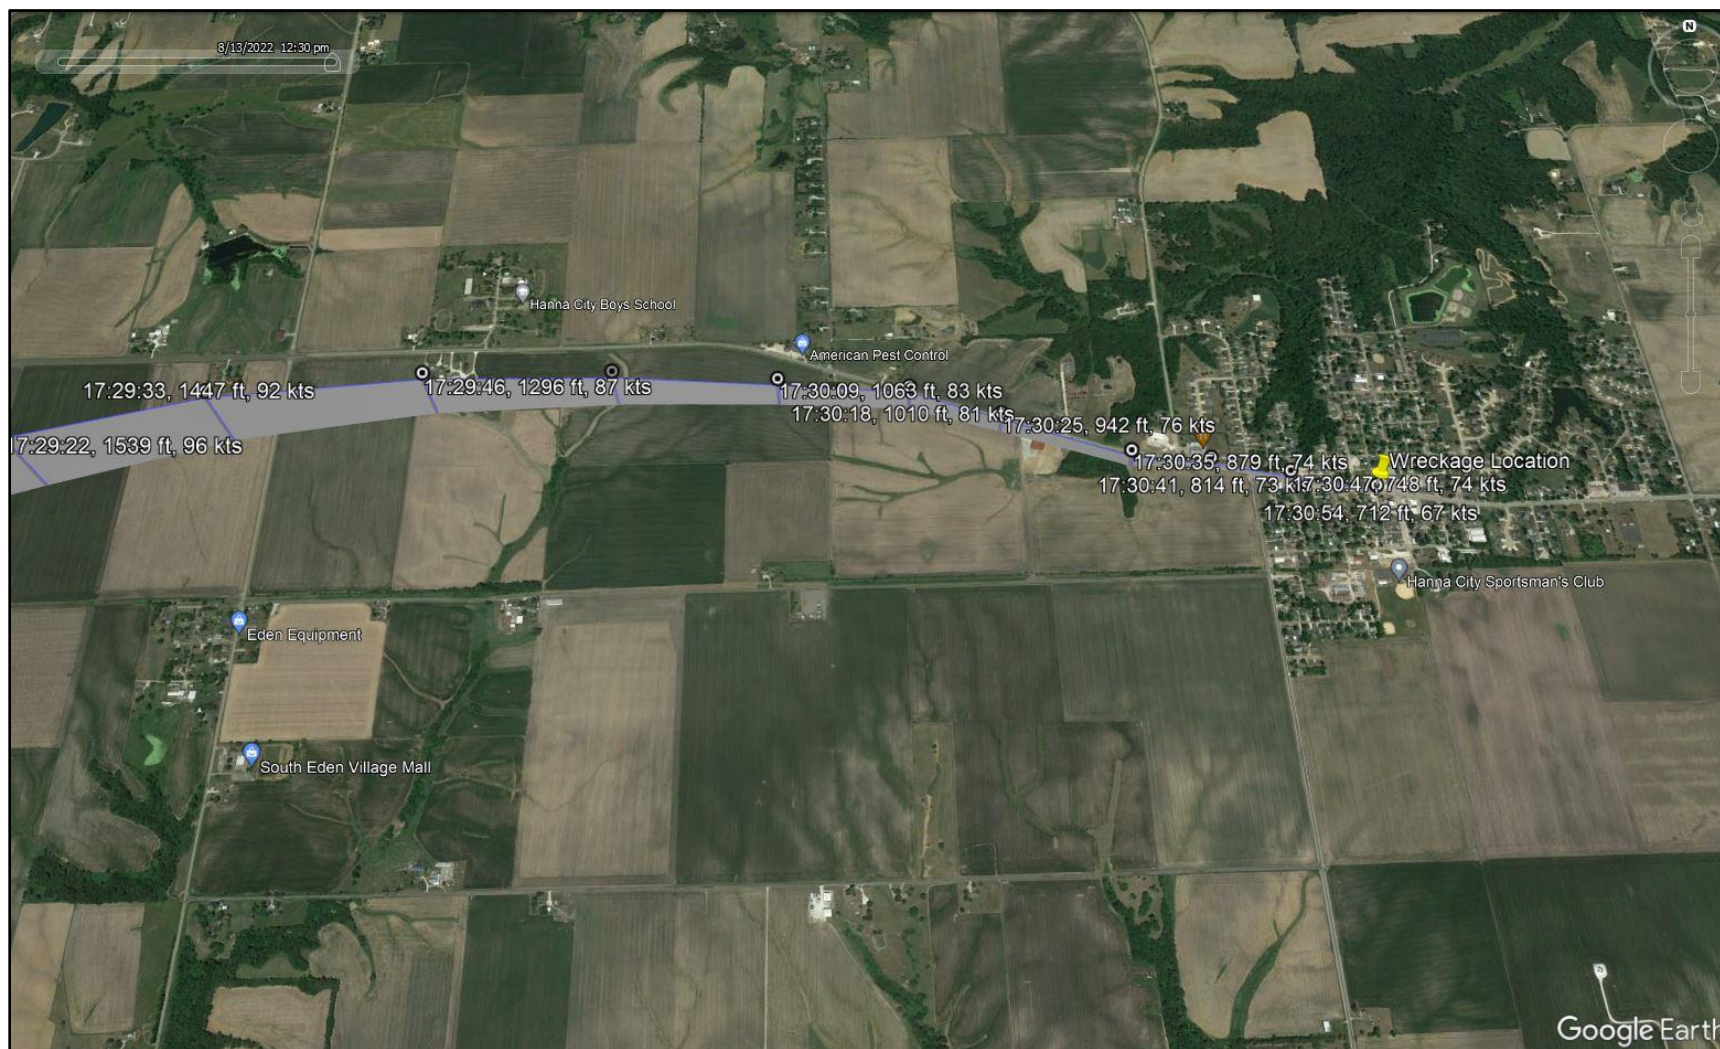
Figure 19 is a graphical overlay generated using Google Earth showing the final portion of the tracklog. The wreckage location is depicted as a yellow pin.

Figure 19. A detailed view of the tracklog data in the vicinity of the accident site. The wreckage location is shown as a yellow pin.
